# Manhole Inspection Summary

Manhole # S47M\_\_005MH

Insp Date: **10/6/08 9:18 AM**

**Location** Address: **2337-5 boston st.**

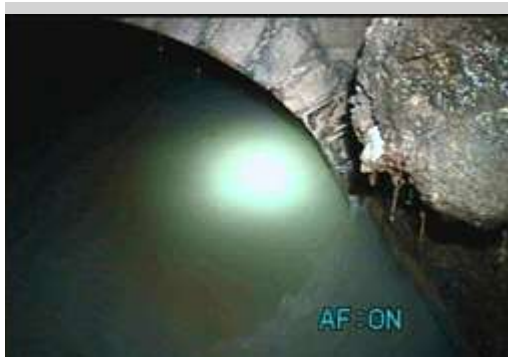
miscellaneous

right side of Pipe @ 6 (45 in)

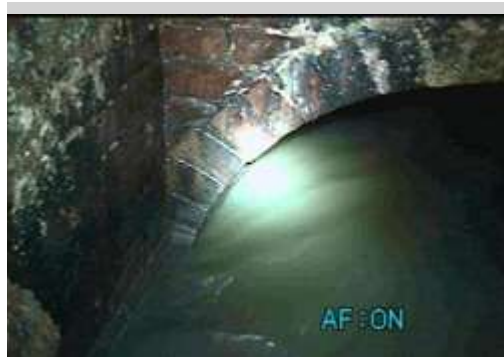
Miscellaneous

left side of Pipe @ 12 (45 in)

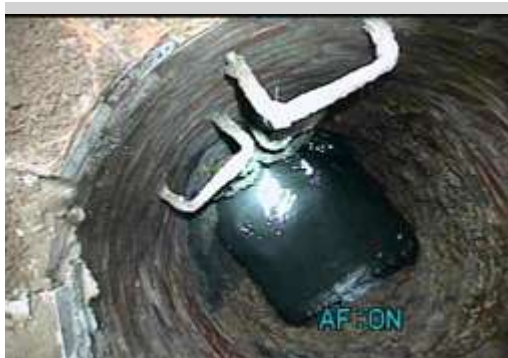
Defect 2

Condition: ☐ Sound ☐ Cracked ☐ Root Intrusion ☐ Loose Brick ☒ **Deteriorated**

**Steps** Count: **8** Missing: **0** ☒ **Corroded**

corroded steps, deteriorating chimney

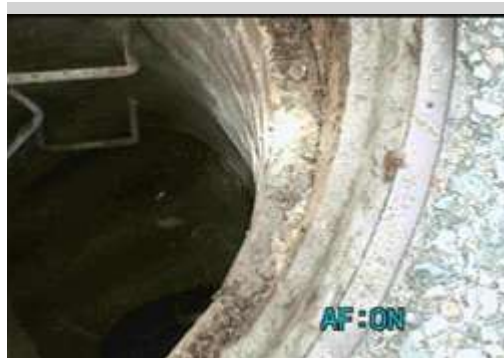
Defect 1

**Frame** Offset: **2** (in.) Condition: ☒ Sound ☐ Cracked ☐ Leaks

frame offset

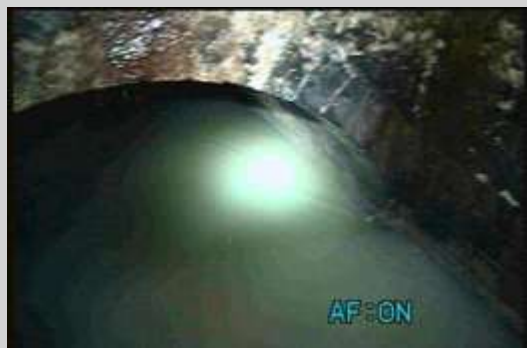
Miscellaneous

right side of 12 (45 in)

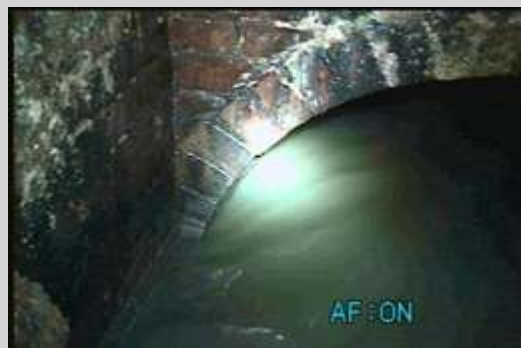
left side of Pipe @ 12 (45 in)

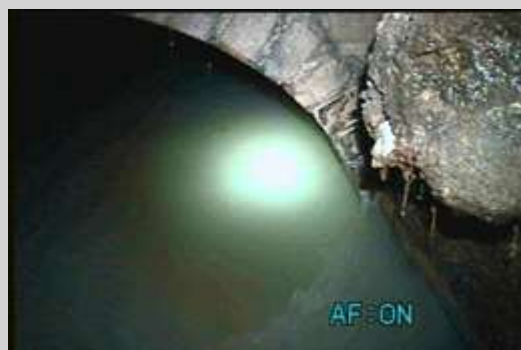
right side of Pipe @ 6 (45 in)
